VRP Project #: 15017Brownfield Site: Yes  $\square$  No  $\boxtimes$

## OFFICE OF ENVIRONMENTAL REMEDIATION **VOLUNTARY REMEDIATION PROJECT** SITE VISIT/INSPECTION REPORT

| APPLICANT | | LRS | |
|---|---|--|---|
| FACILITY:: Freedom Industries STREET ADDRESS:: 1015 Barlow Drive | | | |

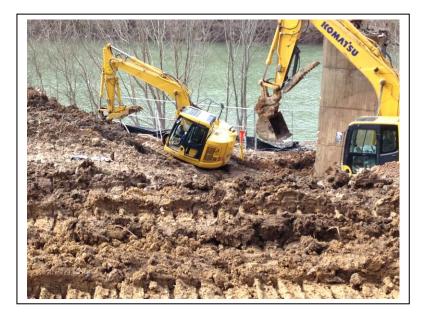
| APPLICANT | | LRS | |
|---|---|--|---|
| Personnel on site were were Kinder Tuckwiller of Core Environmental, Lance Wilcox, Gary Houseman and Larry Cafken who were operating the backhoe equipment. Soil was being redistributed in cut-off trench area on lower level. Area was extremely muddy and equipment was having difficulty operating. | | | |

Figure 1: Equipment working in lower trench area

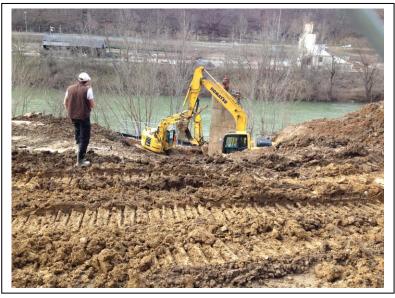
| APPLICANT | | LRS | |
|---|---|--|---|
| Soil currently being redistributed in trench area did exhibit some MCHM odor according to Kinder and was being stockpiled on lower level until a desion is reached for either disposal or placement under cap. Faint petroleum odor still present at site. Scheduled to abandon #13 monitoring well. | | | |

Figure 2: Soil found to contain MCHM in trench area being stockpiled to left of excavator

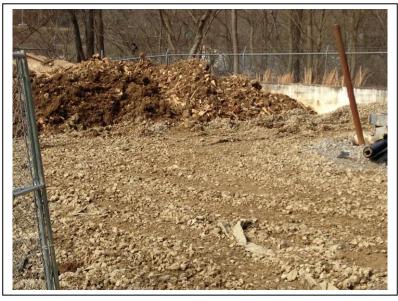
| APPLICANT | | LRS | |
|---|---|--|---|
| 6 loads of contaminated soil from area 4 removed last Friday. | | | |

Figure 3: MCHM contaminated soil from area 4 has been removed
